SALMON AND STEELHEAD HABITAT LIMITING FACTORS

**WATER RESOURCE INVENTORY AREA 17
QUILCENE-SNOW BASIN**

**WASHINGTON STATE
CONSERVATION COMMISSION**

FINAL REPORT

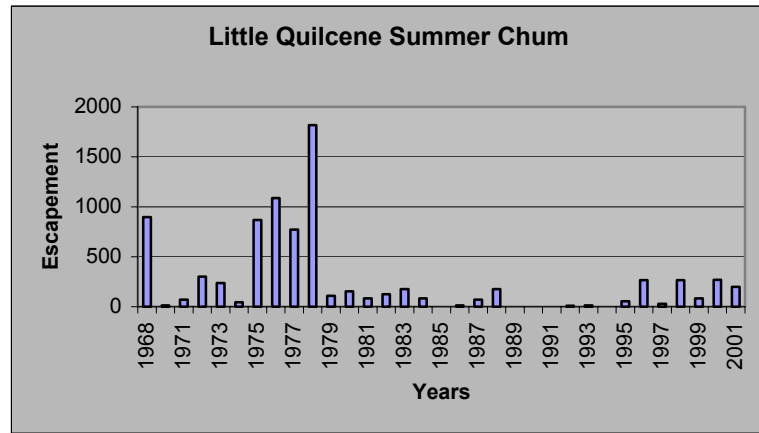
Figure 3. Little Quilcene Summer Chum Escapement, 1968 to 2001. Data provided by Thom Johnson, WDFW

The Little Quilcene River has also experienced a decline in summer chum populations. Adult returns were particularly low between 1989 and 1994. No fish returned in 1990 and 1994. A possible contributor to the decline is over harvest in mixed species fisheries (Lichatowich 1993a; Ames et al 2000). Strays from the hatchery stock-rebuilding program in the Big Quilcene River are finding their way into the Little Quilcene River, which is acceptable since they are considered the same stock. In addition, otolith recovery analysis indicates straying from the Salmon Creek stock.

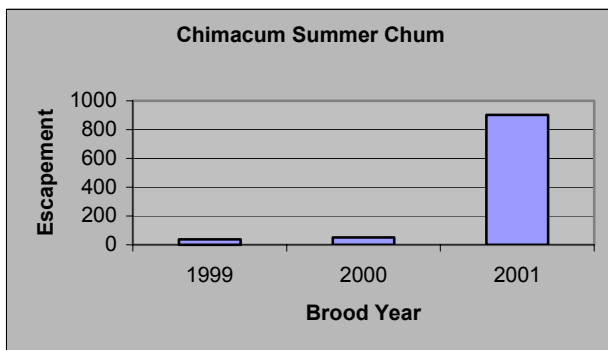
Figure 4. Chimacum Creek Summer Chum Escapement, 1999 to 2001. Data provided by Randy Cooper, WDFW

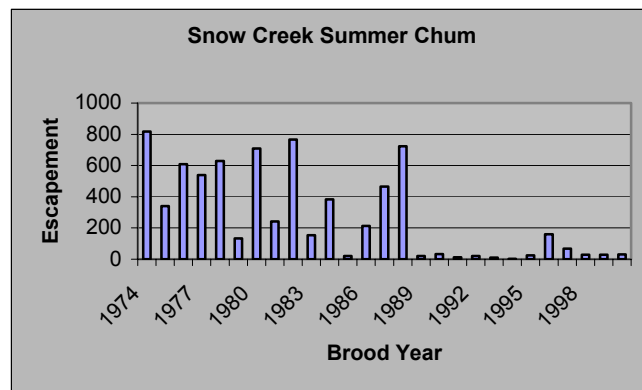
Figure 5. Snow Creek Summer Chum Escapement, 1974 to 2001. Data provided by Thom Johnson, WDFW

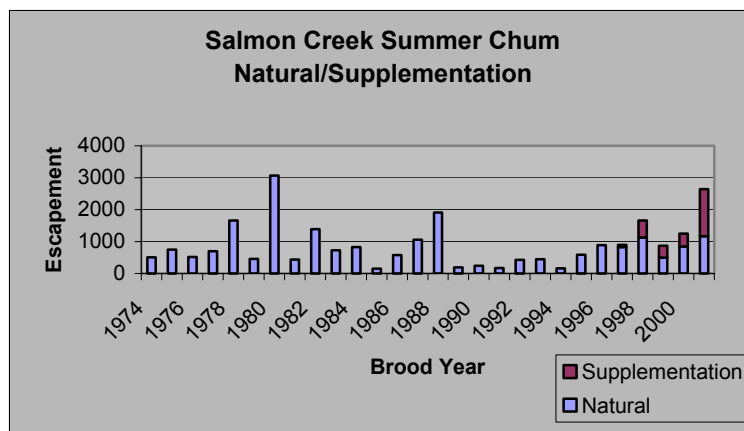
Figure 6. Salmon Creek Summer Chum Escapement, 1974 to 2001. Data provided by Thom Johnson, WDFW

Salmon Creek summer chum have been in critical condition since 1989 (see Figure 6),

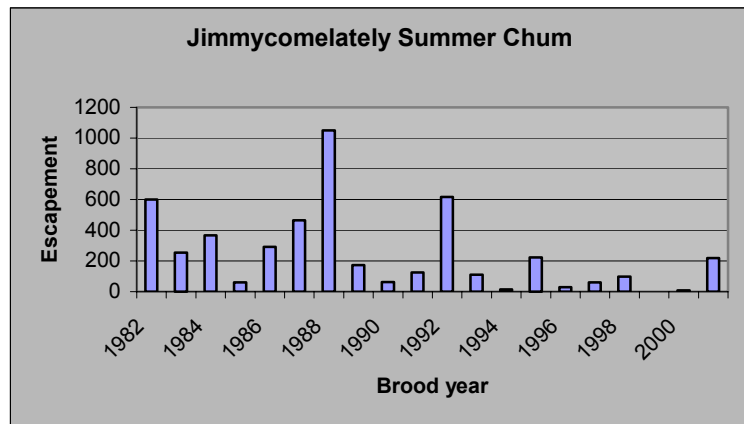
Figure 7. Jimmycomelately Summer Chum Escapement, 1982 to 2001. Data provided by Thom Johnson, WDFW

Estuarine and riverine modifications have created unstable spawning substrate in the lower ½ mile, which may have contributed to stock decline. Stock restoration efforts by WDFW, Wild Olympic Salmon, and local volunteers, with funding from North Olympic Salmon Coalition, began in 1999 and will continue for a maximum of three brood cycles, or 12 years, during which time habitat restoration will have taken place. Jamestown S’Klallam Tribe and Washington Department of Fish and Wildlife have purchased much of the estuary, lower river and nearshore habitats to ensure that proper habitat restoration will provide habitat to sustain a healthy population of summer chum.

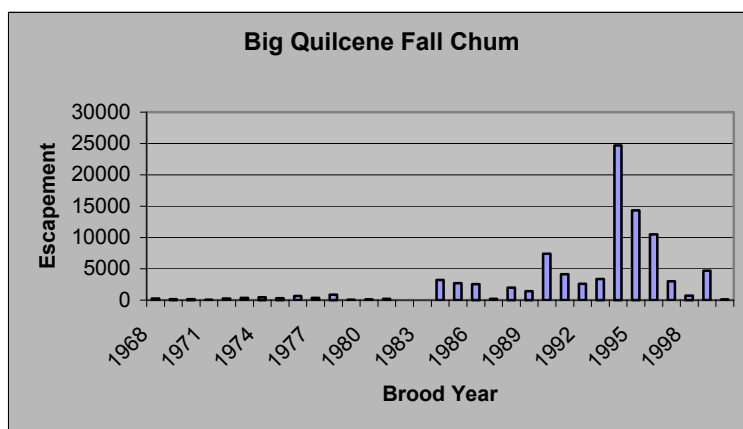
Figure 8. Big Quilcene Fall Chum Escapement, 1968 to 2001. Data provided by Thom Johnson, WDFW.

Escapement records for the Big Quilcene River are available since 1968 (see Figure 8), and show an increase in production after implementation of the stock recovery program at the Quilcene National Fish Hatchery with fry releases beginning in 1992 (see Figure 10).

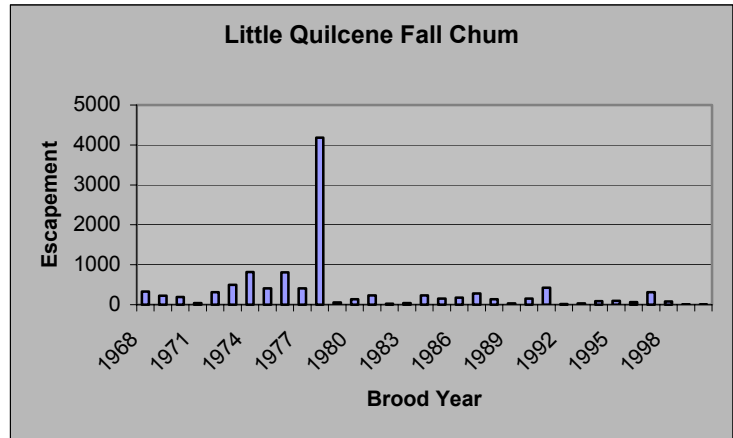
Figure 9. Little Quilcene Fall Chum Escapement 1968 to 2001. Data provided by Thom Johnson, WDFW.

The Little Quilcene fall chum have been monitored since 1968 (see Figure 9) and has been steadily low with the exception of a sudden peak of over 4,000 fish in 1978. In 1999, only seven adults were counted. The Quilcene National Fish Hatchery at river mile 2.3 has released fall chum into the Big Quilcene River since 1992, which probably influenced the increase in returning adults to that system.

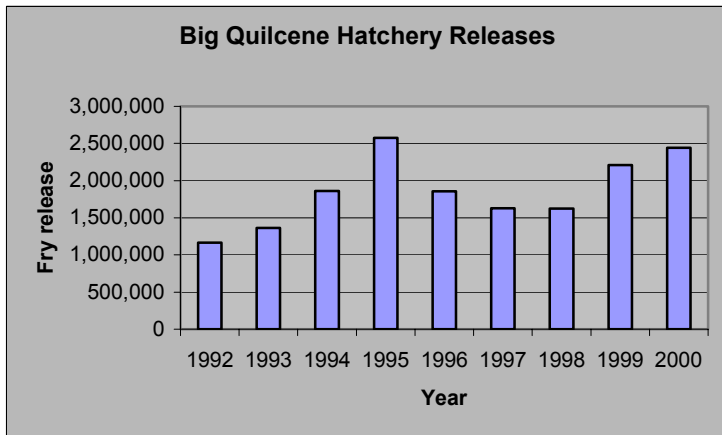
Figure 10. Big Quilcene Fall Chum Hatchery Releases, 1992 to 2000. Data provided by Larry Telles, USFWS

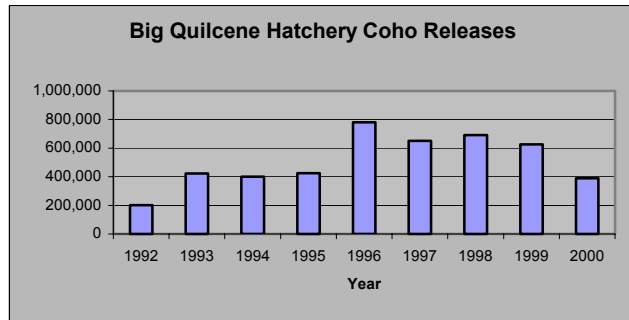
Figure 12. Big Quilcene Hatchery Coho Releases, 1992 to 2000. Data provided by Larry Telles, USFWS.

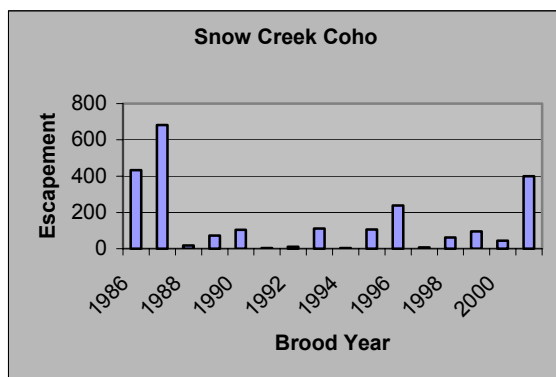
Figure 14. Snow Creek Coho Escapement, 1968 to 2001. Data provided by Thom Johnson, WDFW

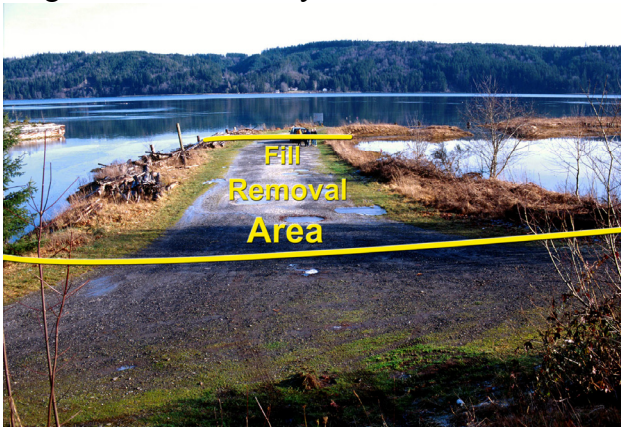
Figure 22. Indian George Creek Estuary, Pre-restoration. Graphic provided by Randy Johnson, WDFW

historic estuary. Recent restoration efforts have removed much of the fill and all the barges to restore estuary function.

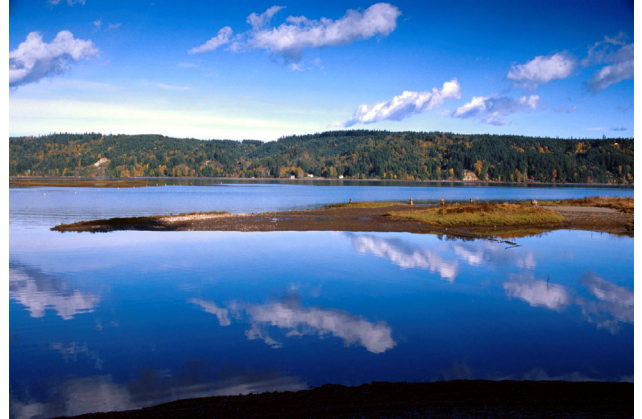
Figure 23. Indian George Creek Estuary, Post-restoration. Photo provided by Randy Johnson, WDFW

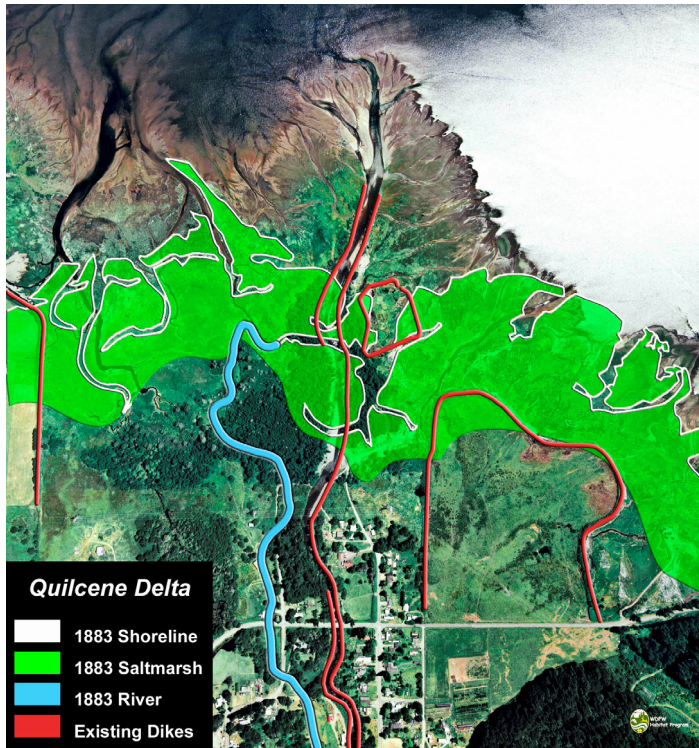
Figure 25. Big Quilcene River Estuary. Graphics provided by Randy Johnson, WDFW

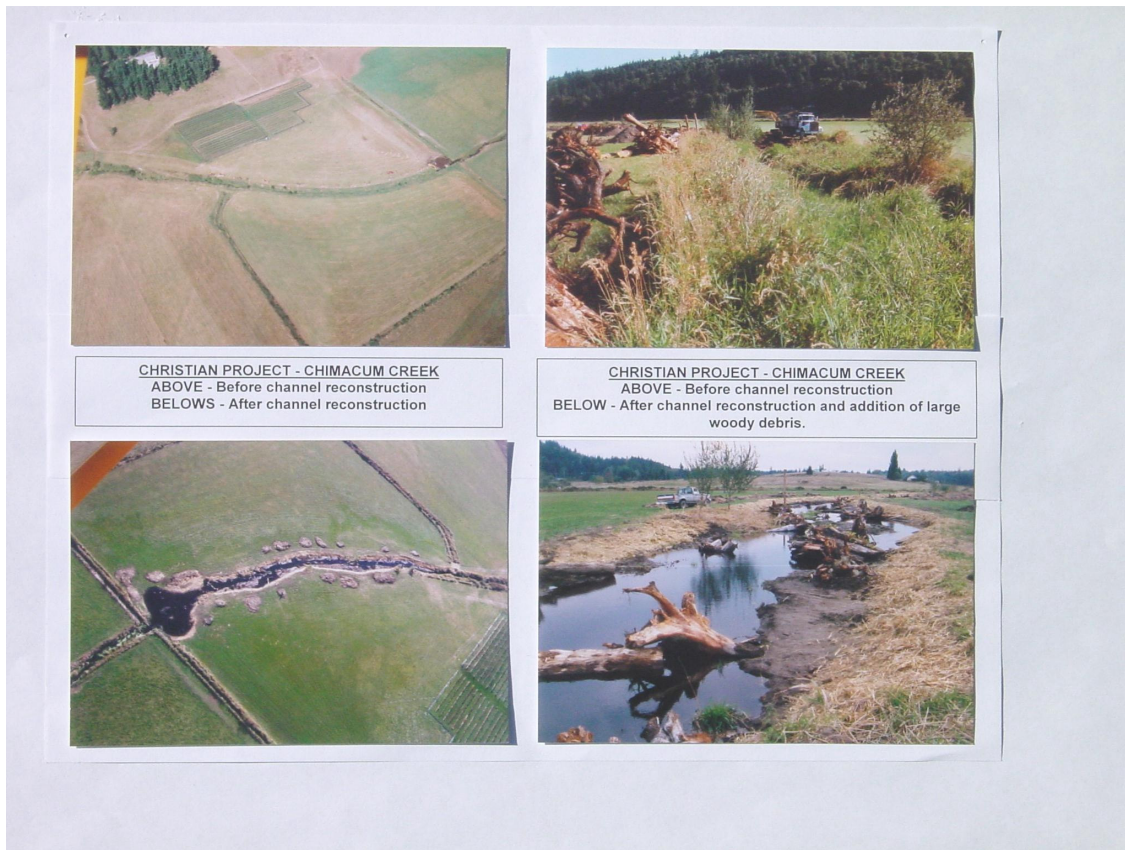
Figure 55. Chimacum Creek Habitat Restoration. Photo provided by Al Latham, JCCD

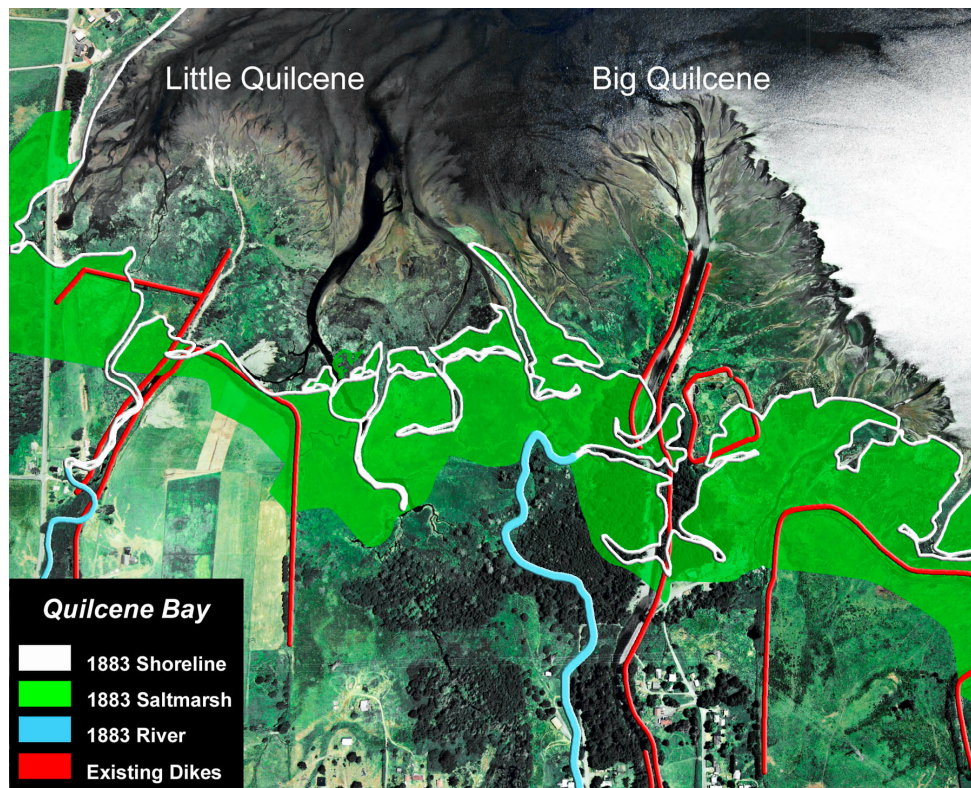
Figure 77. Big Quilcene and Little Quilcene Estuary Modification. Graphics provided by Randy Johnson, WDFW

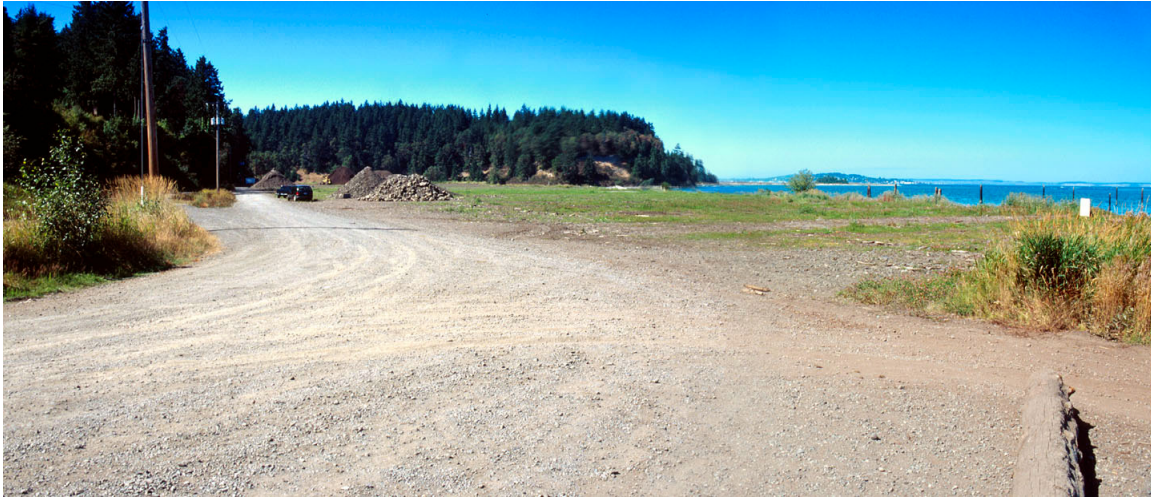
Figure 84. Chimacum Creek Nearshore, Existing. Photo provided by Randy Johnson, WDFW

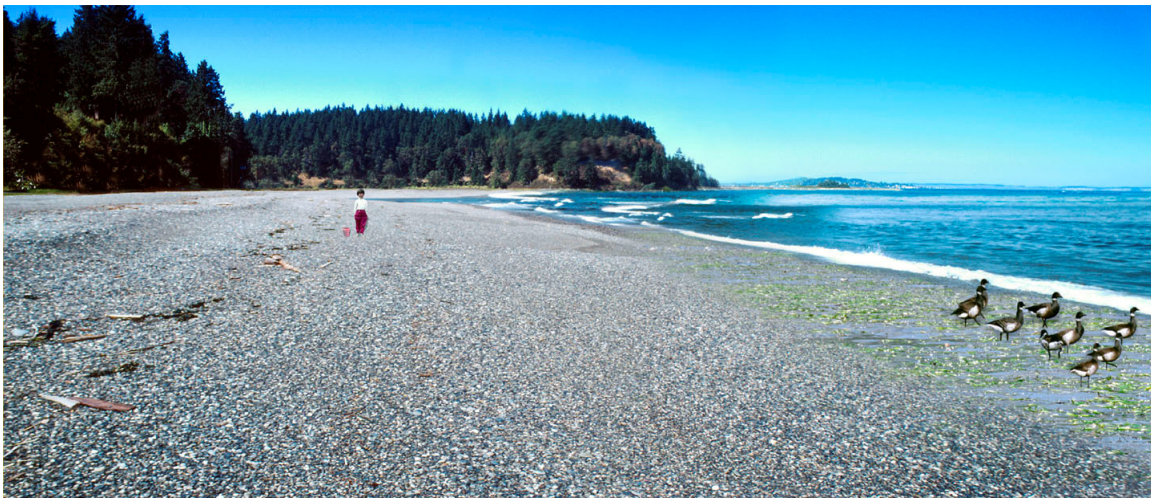
Figure 85. Chimacum Creek Nearshore, After Proposed Restoration. Graphic provided by Randy Johnson, WDFW

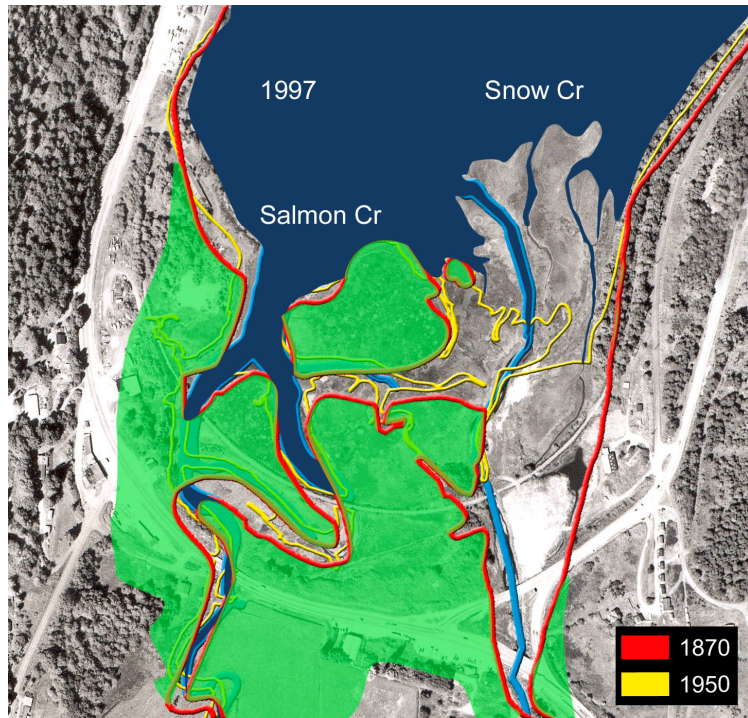
Figure 89. Salmon and Snow Estuaries with Historic Overlay.
Graphic by Randy Johnson, WDFW

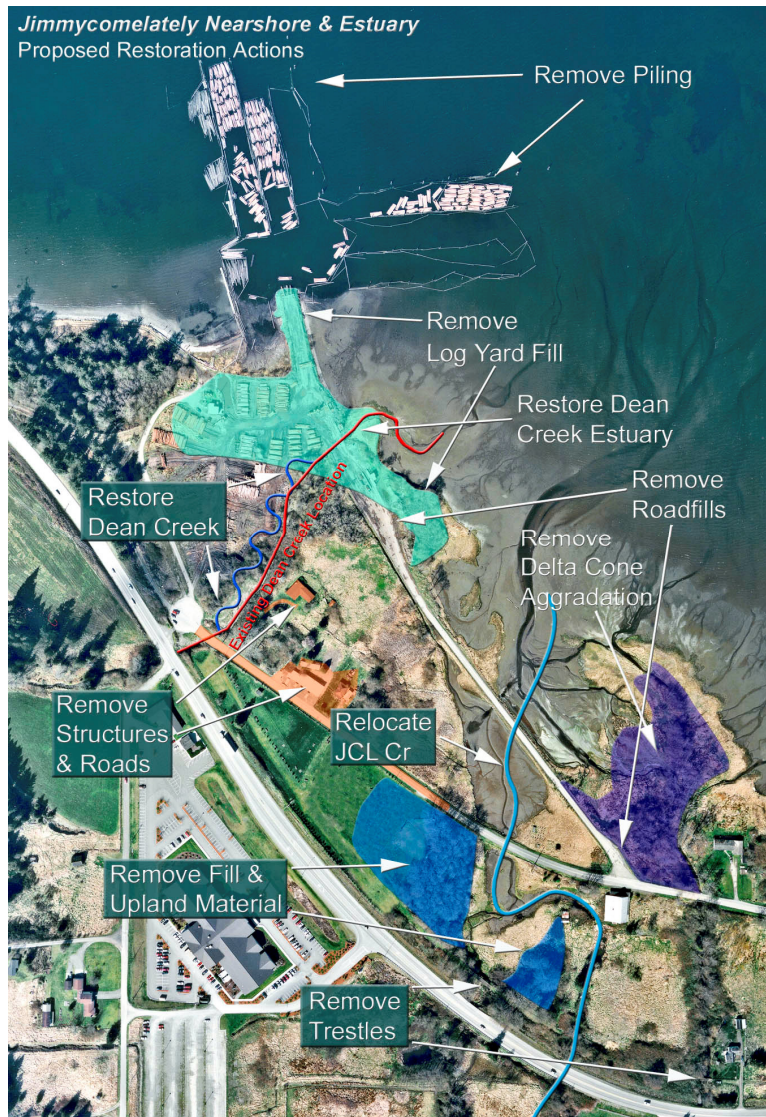
Figure 92. Jimmycomelately Estuary with Proposed Restoration Actions. Graphic by Randy Johnson, WDFW
